Pollution Prevention Assessment Summary

PREPARED FOR: The City of Portsmouth
PREPARED BY: Celeste Ostman/CH2M
DATE: May 22, 2017
PROJECT NUMBER: Task 3.3: City Facilities

Attachment A
I.C. Norcom High School Pollution
Prevention Assessment

Attachment B
Churchland High School Pollution
Prevention Assessment

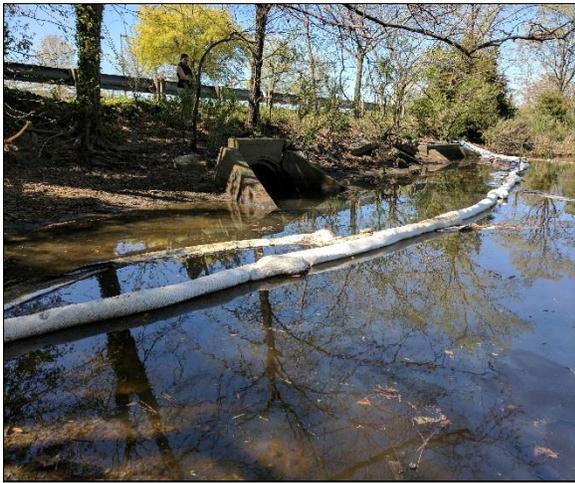
Photo 001: Outfall for most of the school's campus. There was a sheen from a leak at an adjacent gas station

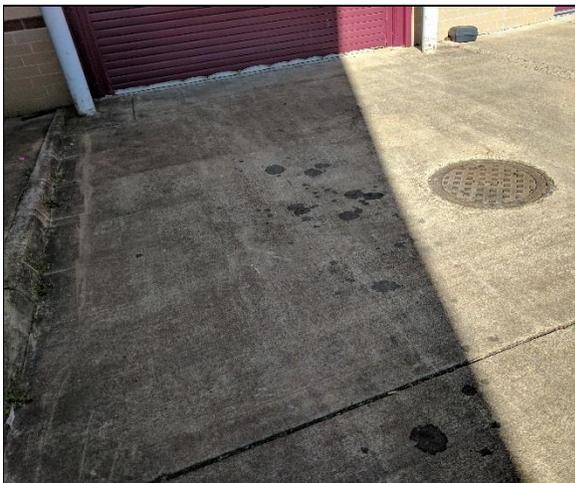
There is a stain by the athletic fields of unknown origin or substance and minor stains in both the loading/unloading area and the student/staff parking lot (see Photos 006, 003, and 007, respectively, in the photo log)

There is a loading/unloading area along the eastern side of the main building (see Photo 003 in the photo log).

There is a grease trap that services the cafeteria in the loading/unloading area (refer to Photo 003 in the photo log). Tom Marsh/Portsmouth stated that all the school grease traps will be cleaned out twice a year.

Photo 003: Minor stains at the loading/unloading area by the cafeteria

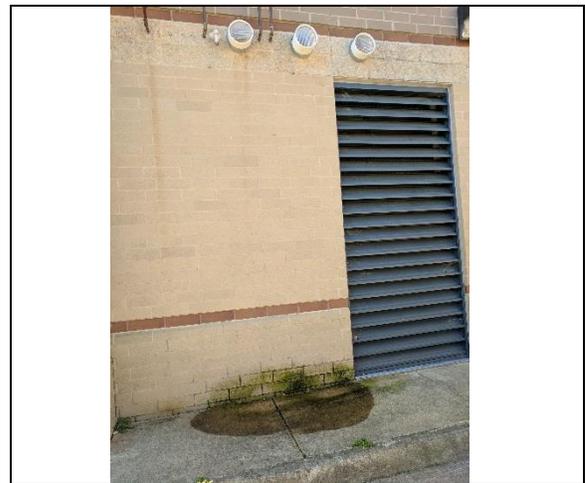
There was minor AC condensate on the sidewalk by the loading/unloading area (see photo 004 in the photo log).

Photo 004: by the wood working shop off the southwestern corner of the main building

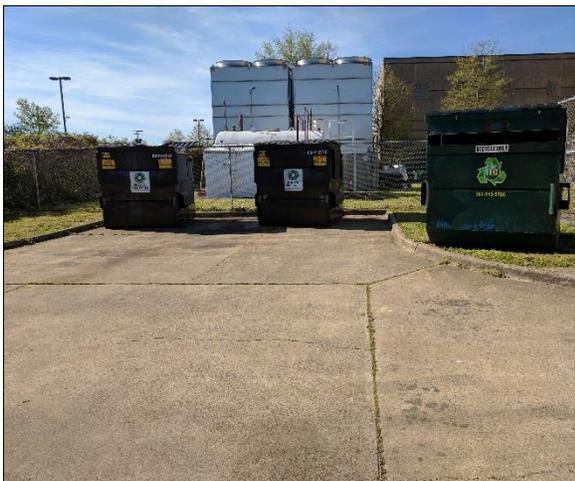
There were domestic waste dumpsters by the loading/unloading area (see Photo 005 in the photo log). There were several smaller, general use trash cans around the site as well.

Photo 005: Dumpsters by the loading/unloading area

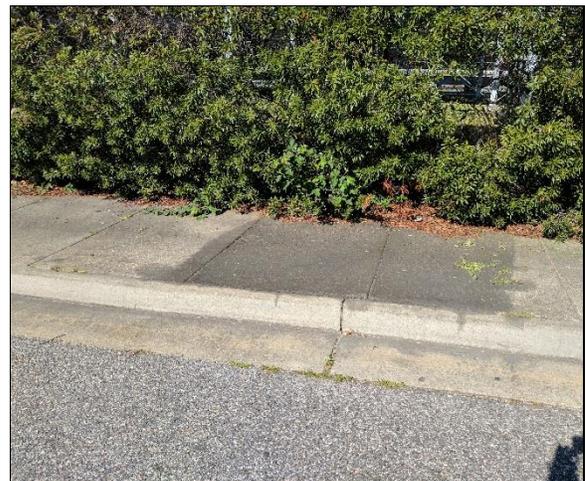
Photo 006: Stain of unknown origin or substance

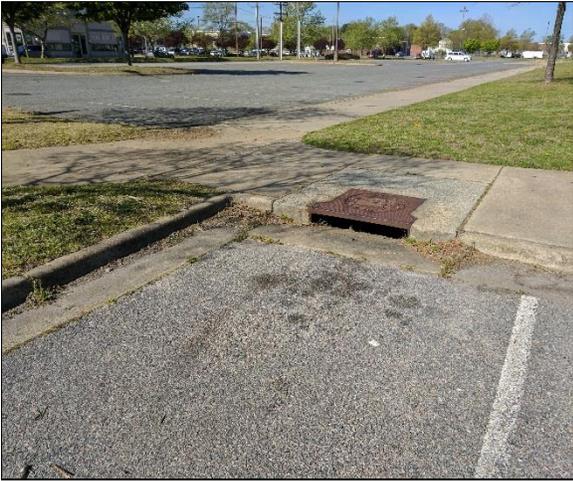
Photo 007: Stain believed to be from mop water and waste water from refinishing the boiler room floor

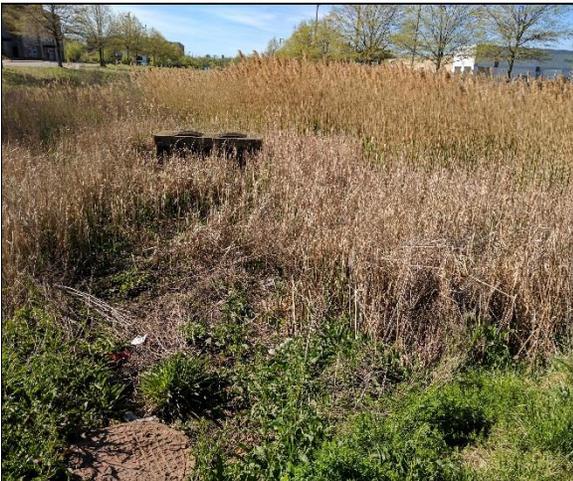
There is a retention area was designed in 1995 and construction was finished in 1997 according to Tom Marsh/Portsmouth and he was able to provide the original plans for the high school. Per the plans, trees were to be planted along the perimeter, but no other vegetation was called for within the basin on the plans. As seen in Photos 008, 009, and 010 in the photo log, the SWMF has become quite overgrown with vegetation and is collecting trash. The SWMF was built prior to the VSMP standards for building SWMFs was released and it is assumed that the retention area was designed to control quantity of runoff only. This makes the retention area eligible to be retrofitted for credit should Portsmouth choose to do so.

Photo 009: Overgrown retention area

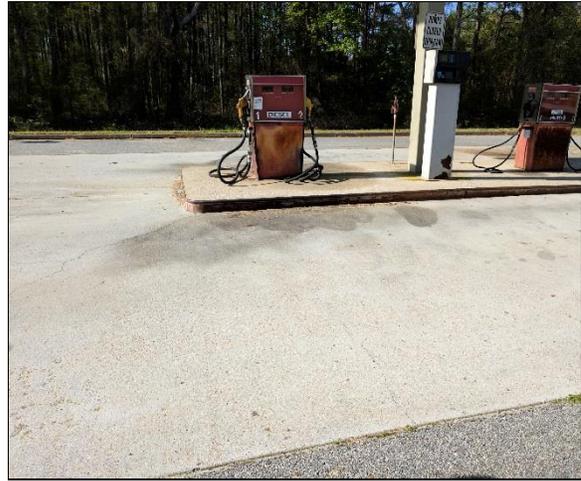
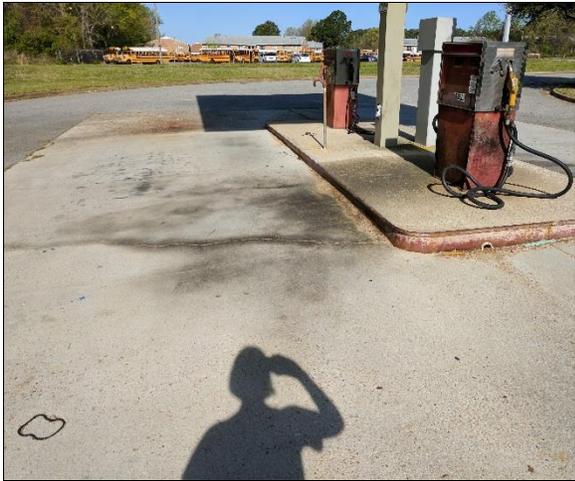
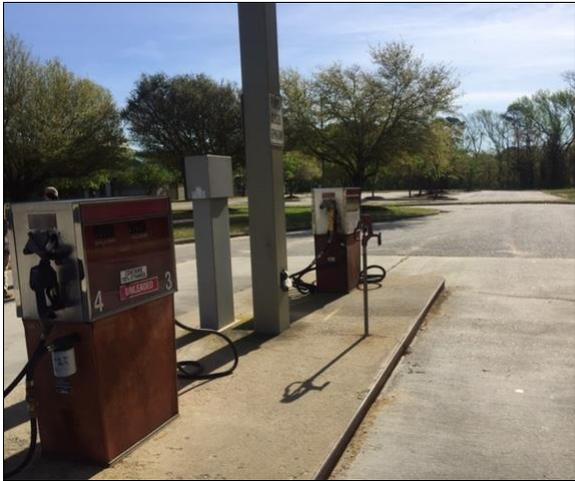
There is a fueling station in the southwestern corner of the campus (see Photos 002, 003, and 021 in the photo log). The fueling station is covered, but there were no obvious spill kits onsite. This area already has a SWPPP and the bus parking lot was being added to the document. The inlets included in the area covered by the SWPPP will need to be marked per Part I Section B.i.1.e of the MS4 permit.

Photo 002: Fueling station in the southwestern part of the campus

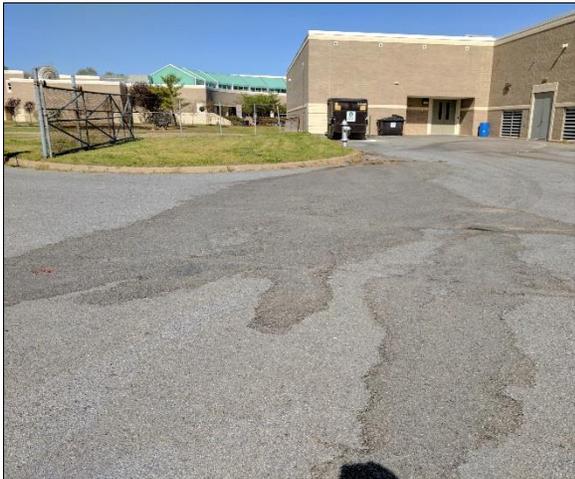
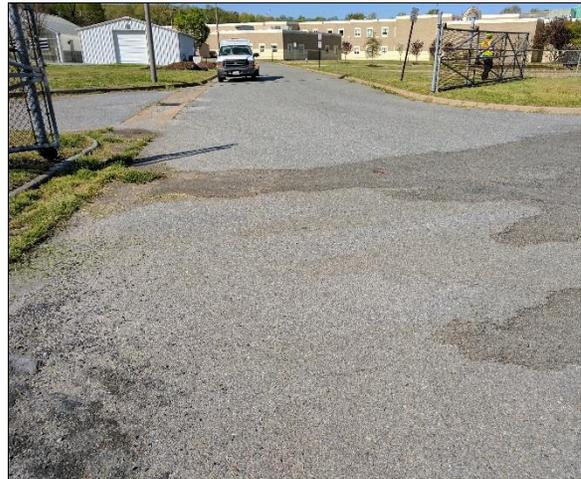
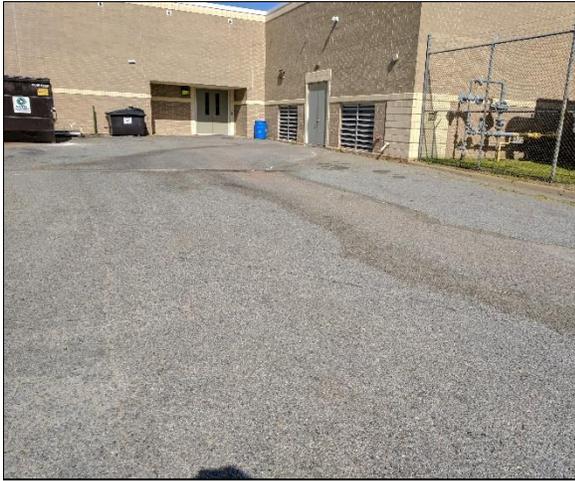
There are two areas that have dumpsters and recycling bins and there is minimal trash around the site. There are two loading docks along the eastern side of the main building. The northern loading dock had stains that started at the door and went to the storm drain, Figure 2. Tom Marsh from the City stated that he believed it was from mop water and waste water from a scrubber which contains wax and "green stripper" from when the school refinishes the boiler room floor. He asserted that the water

should be dumped down the sanitary sewer and that this has been conveyed to the maintenance and janitorial staff on several occasions.

There is a stain in the loading area by the cafeteria on the eastern side of the building (see Photos 005, 006, and 007 in the photo log). Most likely mop water and possibly waste water from refinishing the boiler room floor according to Tom Marsh/Portsmouth.

Photo 005: Stain believed to be from mop water and waste water from refinishing the boiler room floor

In general, there were little potential pollutant sources at the three high schools. There was some concern with the improper disposal of wash water from mop buckets and waste water from refinishing the boiler room floors. It is believed that this can be remediated by having a training for custodial, maintenance, and food service staff on stormwater pollution prevention and good housekeeping practices. CH2M recommends that the City resume stormwater training at in-service meeting before school starts.

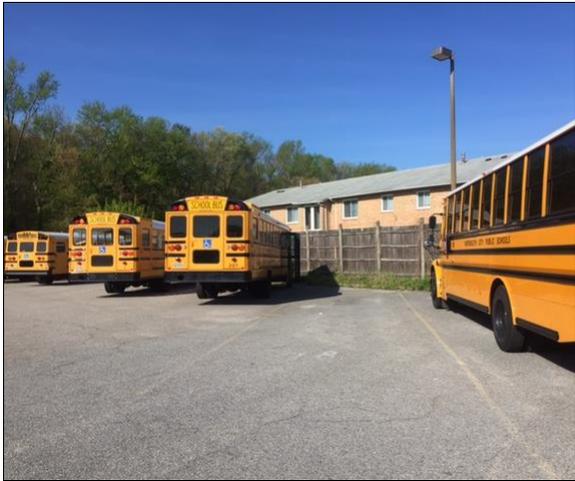
The buses parking area is in the southwestern corner of the campus and there were very few stains on the pavement suggesting the buses are well maintained (refer to Photo 015 in the photo log). There was no other equipment noted onsite.

Photo 015: Bus parking area in the southwestern corner of the campus with very few stains on the asphalt

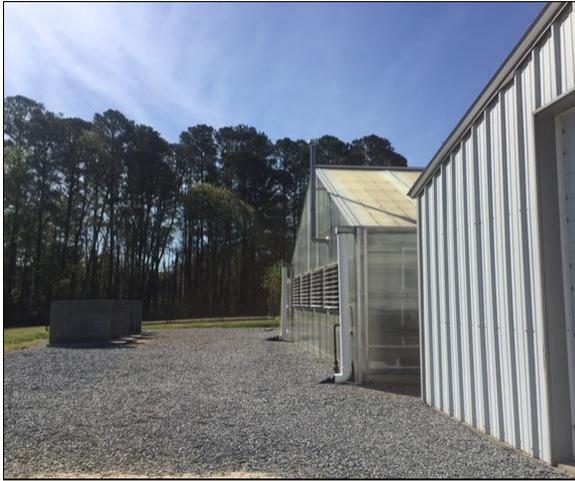
While onsite, it was discovered that there were roof drain disconnections installed when the green house was built on the eastern side of the site. The operation appeared to be fairly new and in good condition. The roof drain disconnections will need to be added to the City's SWMF database and inspected annually per the MS4 permit (see Photos 019 and 022).

Photo 019: Greenhouse roof drain disconnection

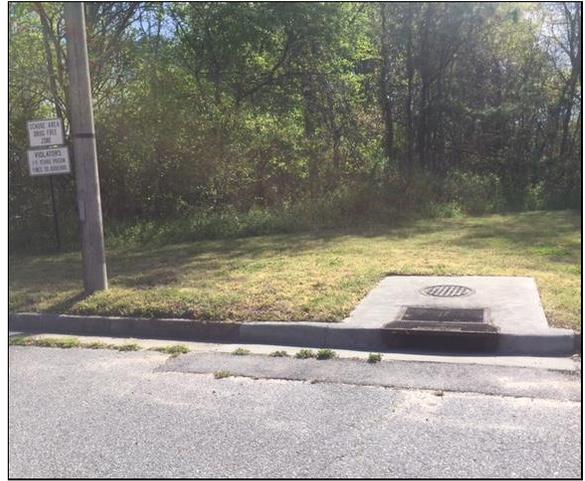
Photo 020: Storm drain that leads directly into Craney Island Creek

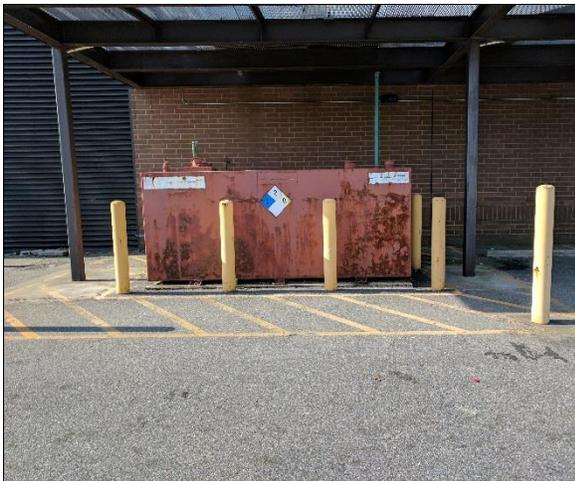
There were no material storage areas. There was an old, empty fuel tank under an overhang in the loading/unloading area on the north side of the school (see Photo 003 in the photo log). Tom Marsh/Portsmouth stated that there were currently no plans to remove the empty tank due to the cost.

Photo 003: Empty boiler fuel tank no longer in service

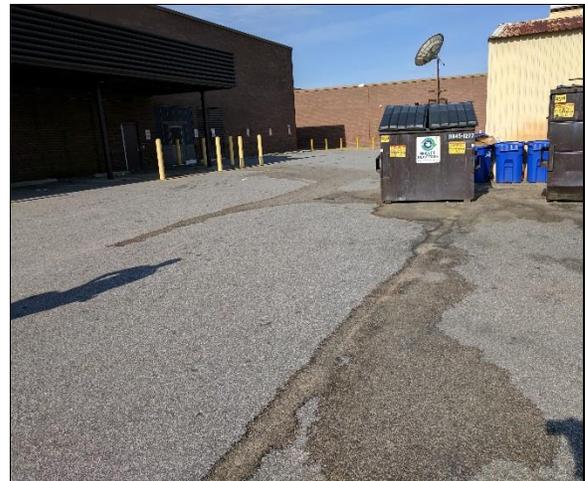
There is a stain in the loading area by the cafeteria on the northern side of the building (see Photo 004 in the photo log). Most likely mop water and possibly waste water from refinishing the boiler room floor according to Tom Marsh/Portsmouth.

Photo 004: Stain believed to be from mop water and waste water from refinishing the boiler room floor

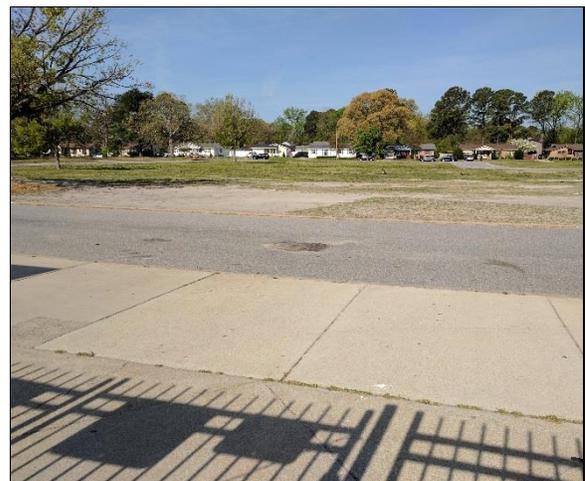
There is a small area by the athletic fields that is used for overflow parking during large events that does not have good ground cover (see Photo 006 in the photo log).

Photo 006: Unstabilized area used as overflow parking during large events.
