HISTORIC DISTRICT HOMES - ROOF ANALYSIS

February 3, 2015

REPORT OBJECTIVES

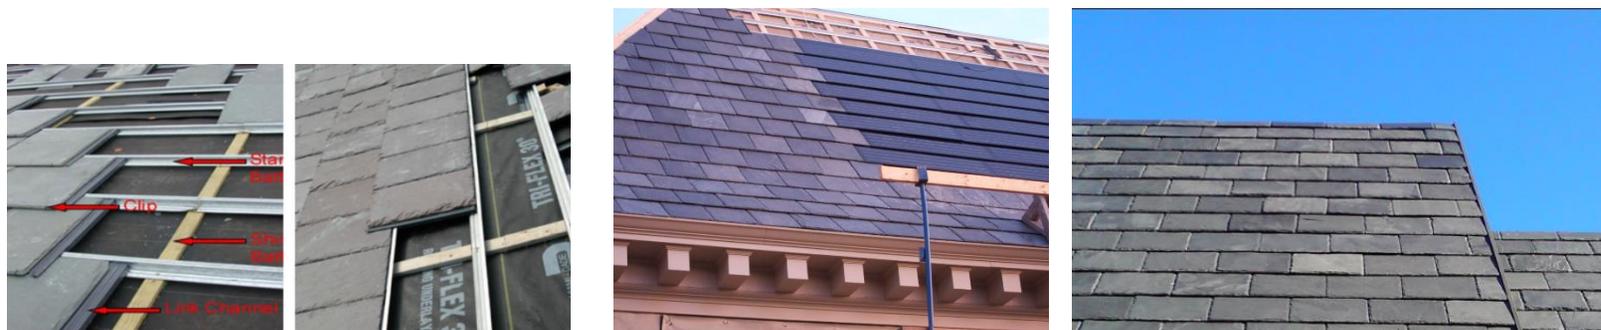
Example Images of Engineered Slate Roof Shingles:

Drawbacks: Roughly the same cost as conventionally laid slate once the cost of the furring system and labor are factored in. The value of an engineered slate roof system lies primarily in the savings that comes with the reduced roof structure.

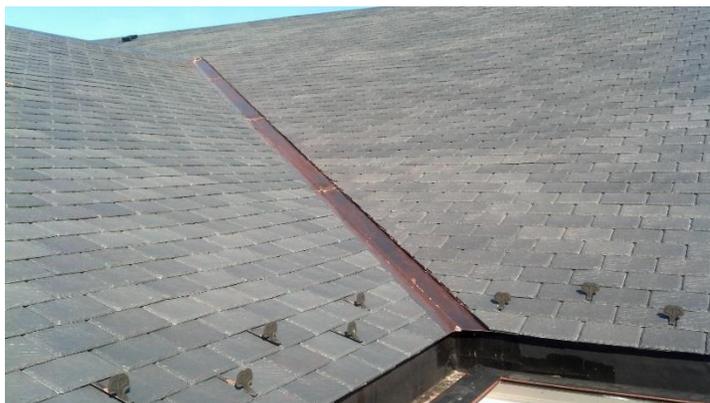
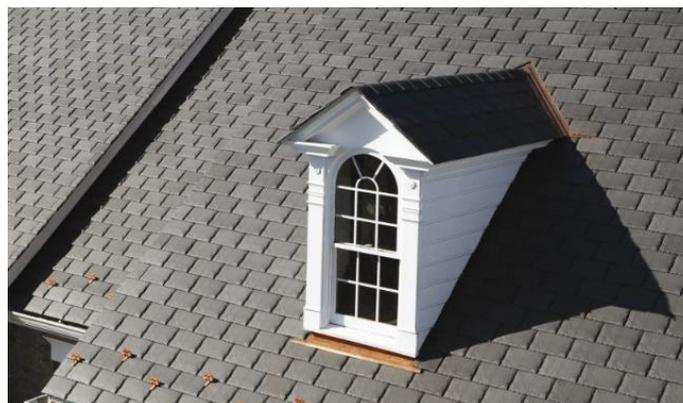
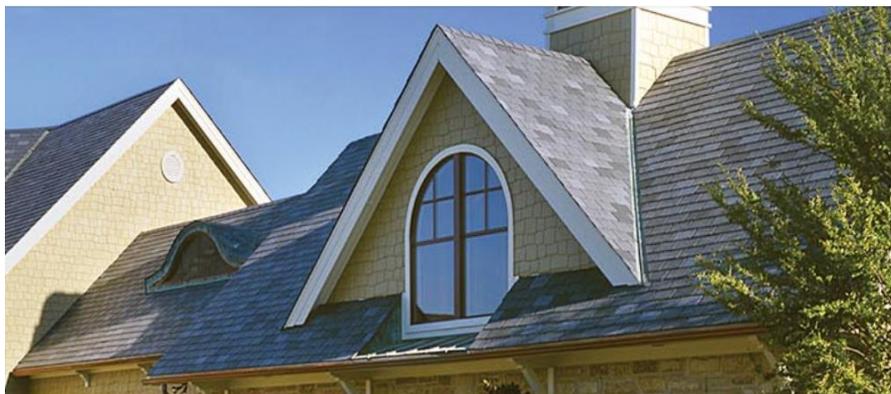
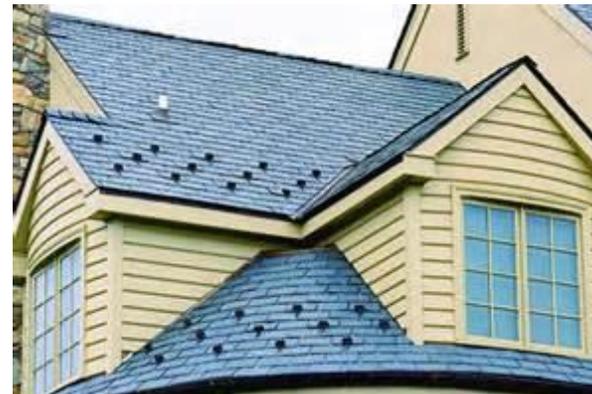
Example Images of Synthetic Slate Roof Shingles:

b) Synthetic Slate Shingles: Synthetic slate is made primarily of rubber (EPDM - Ethylene Propylene Diene Terpolymer) and plastics (TPO - Thermoplastic Polyolefin), installed in individual shingles, like slate, over an underlayment of either self-adhered product, synthetic roofing paper, or felt roofing paper.

Benefits: Less weight and cost than slate while having the appearance of slate.

Drawbacks: Some synthetic shingles have been known to have color-fading problems in the past. Most products are improved and many offer warranties for color-fade. Though the material is less expensive than slate, labor is more expensive than asphalt shingles.

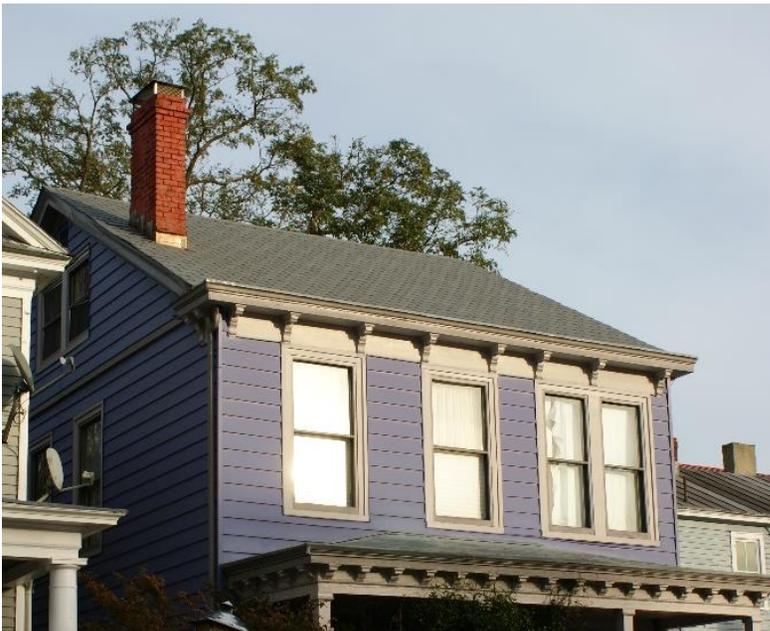
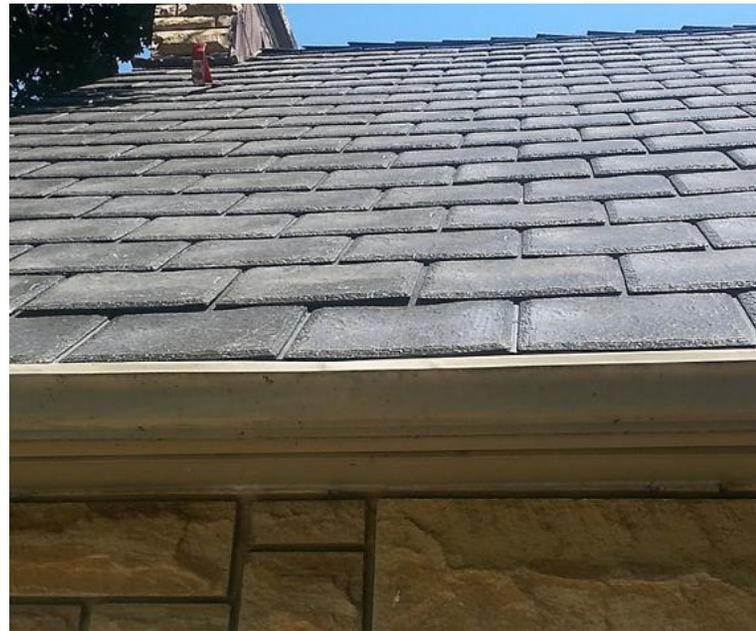
Example Images of Composite Synthetic Slate Roof Shingles:

c) **Composite Synthetic Slate Shingles (“Enviroslate”):** A rather new material on the market, Enviroslate is a composite synthetic slate product made of recycled plastics and cellulosic fibers manufactured by *Enviroshake Inc.* It is not susceptible to mold, mildew, fungus, rot or insect infestation. It should be noted that there is a property in Olde Towne (as seen in the photo image at bottom left) on which this product has recently been installed.

Benefits: Less weight and cost than slate. Material is less expensive than most other synthetic slates as the product is purchased direct from the company in lieu of through a supplier. Currently the company wants to control the quality of installation, so installers must be certified before they can purchase and install the product.

Drawbacks: The product is new on the market. With its newness comes inherent risks of the ‘unknowns’ of how the product will perform in its environment over a longer period of time. The company that makes the product has been producing a cedar alternative known as Enviroshake since 1998 with success.

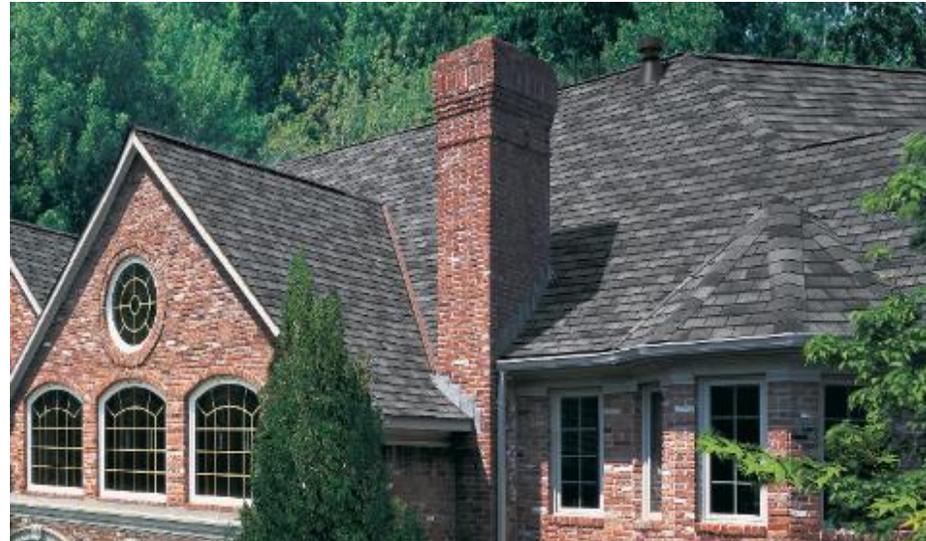
Example Images of Premium-Grade Asphalt Shingles:

d) Premium-Grade Asphalt Shingles ('Camelot' or Slateline by GAF (General Aniline & Film) Materials Corporation, GrandManor of Carriage House by CertainTeed Corporation): Asphalt-impregnated fiberglass shingles with granulated cap shingle. Thicker than an architectural grade shingle (425 lbs. per square) with a 'shadow line' aesthetic. Wind resistance rating of UL (Underwriter's Laboratory) certified to meet ASTM D3018 Type 1 and ASTM D3161, Class F, 110 mph wind resistance. Resistant to fungal coloration.

Benefits: More economical than slate or synthetic slate, and more aesthetically impactful than standard architectural-grade shingle. Thicker shingle provides more profile. Comes in a range of shapes (scalloped, etc.).

Drawbacks: More expensive than standard architectural-grade asphalt shingles. Nonetheless it does not look like slate. This product does differentiate itself from a standard asphalt shingle in scale and profile, but it does not have an historical appearance.

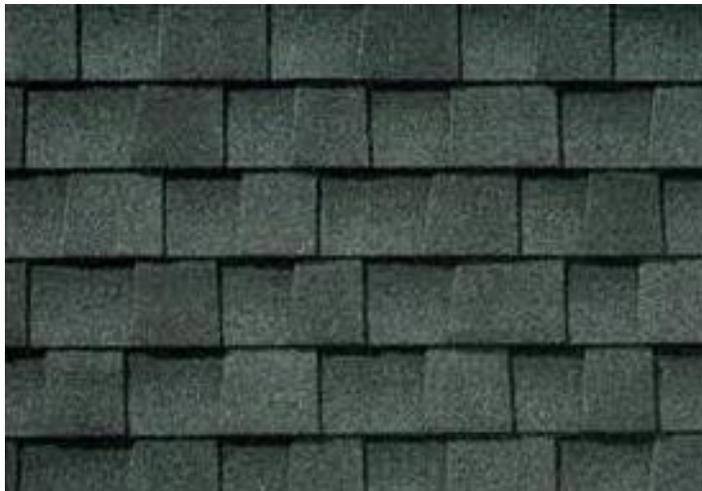
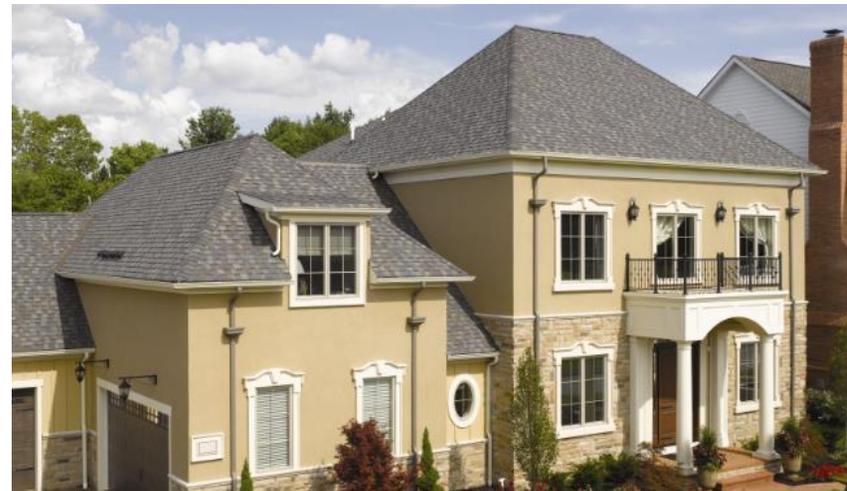
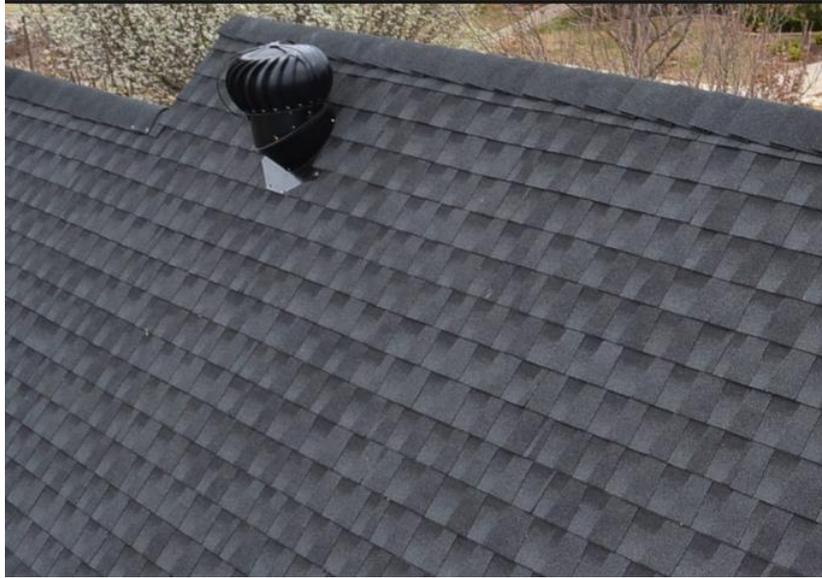
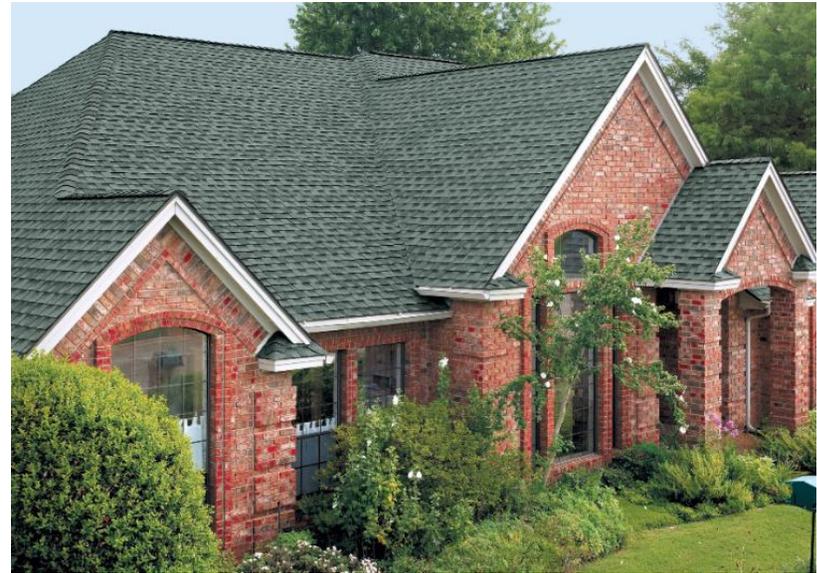
Example Images of Architectural-Grade Asphalt Shingles:

e) Standard Architectural-Grade Asphalt Shingles (e.g. Timberline by GAF Materials Corporation): Architectural-Grade Asphalt Shingles are asphalt-impregnated fiberglass shingles with granulated cap shingle. Though they do not have as much thickness and definition as Premium-Grade shingles, these shingles still provide a shadow-line and texture superior to the standard flat 3-tab shingles. Two types of base materials are used to make asphalt shingles: A formerly-living organic base and fiberglass base. Both types are made in a similar manner with asphalt or modified-asphalt applied to one or both sides of the asphalt-saturated base, covered with slate, schist, quartz, vitrified brick, stone, or ceramic granules and the back side treated with sand, talc or mica to prevent the shingles from sticking to each other before use. The top surface granules block ultra-violet light which causes the shingles to deteriorate provides some physical protection of the asphalt and gives the shingles their color. Some shingles have copper or other materials added to the surface to help prevent algae growth.

Benefits: Most economical of all the above options but still having a relatively appealing appearance due to the shadow-line texture and profile on the shingles in addition to improved fungus resistance.

Drawbacks: This shingle is the least look-alike to slate. Due to the widespread use of this product on properties throughout the United States, the installation of this type of shingle in 'historic districts' runs the risk of creating a neighborhood that does not differentiate itself from other modern-day neighborhoods.

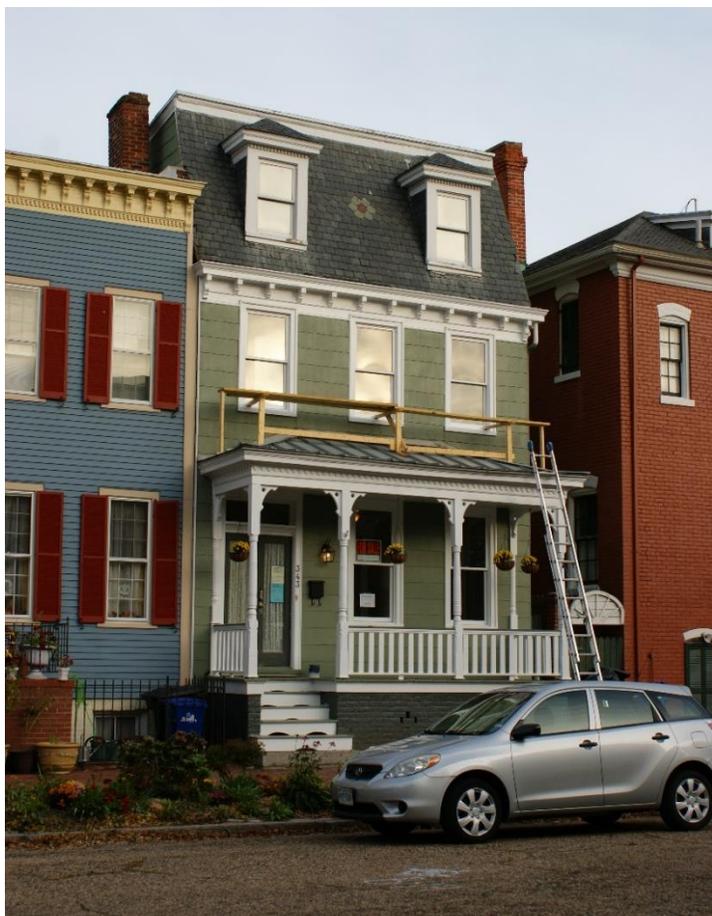
343 Court Street, Olde Towne

Mansard slate roof exhibits stains from adjacent painted surfaces. Flower pattern detail, composed of green and burgundy hexagonal slate, provides a charming feature aesthetic on front façade.

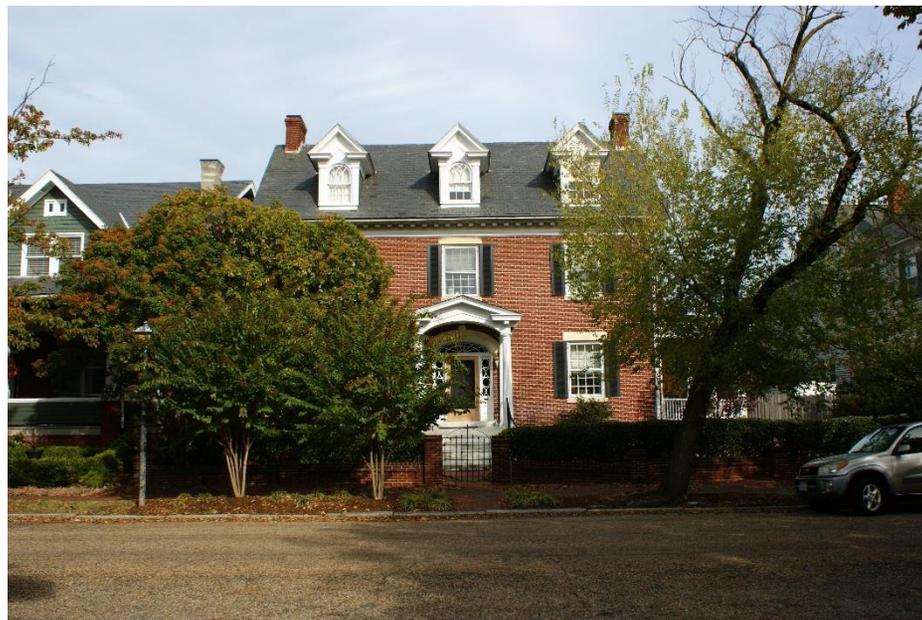
516 North Street, Olde Towne

Georgian home is complemented with slate roof. Some areas of slate shows signs of moderate damage and should be inspected by a qualified slate roofer.

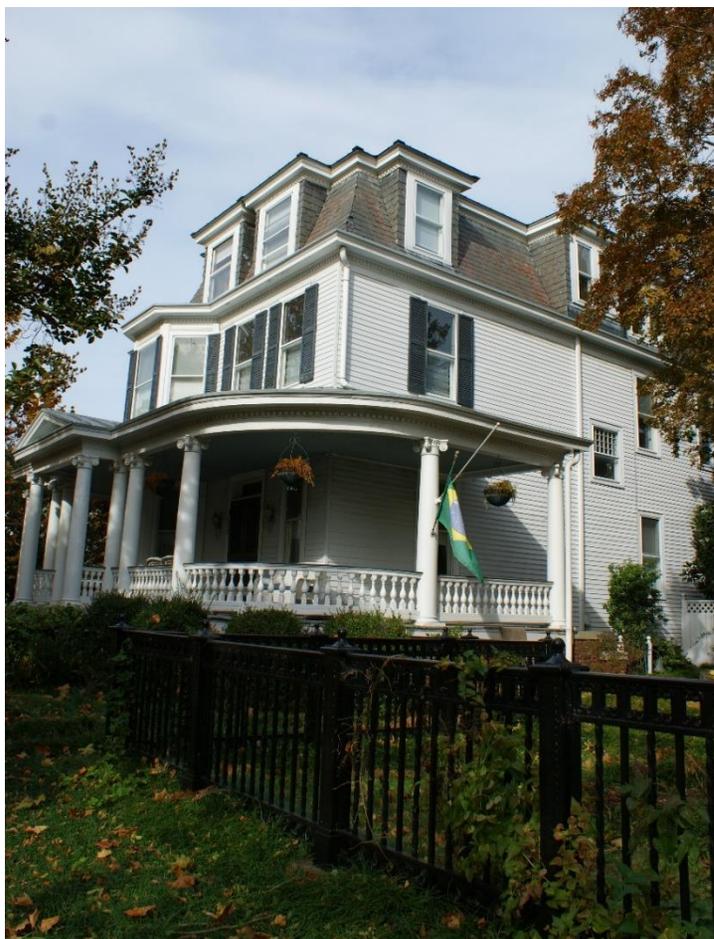
532 Court Street, Olde Towne

Steeply pitched mansard roof expresses the slate roofing from the street view. Slate is also installed on the sidewalls of the dormers. Complicated geometries require the employment of a qualified slate roofer.

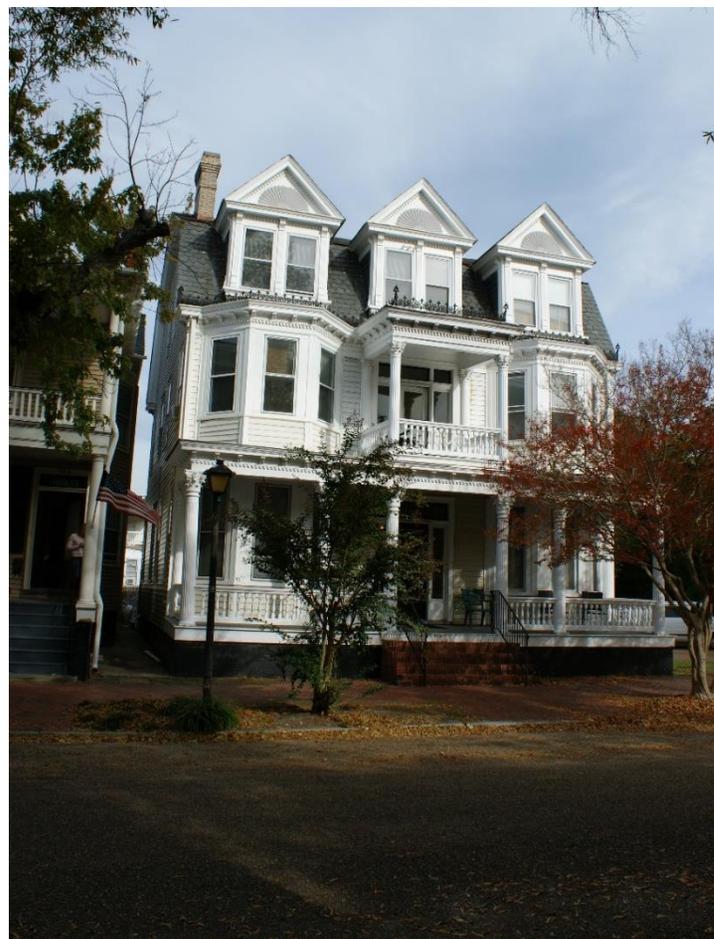
424 North Street, Olde Towne

Dormers dominate the roof façade of this residence. Subtle detailing of diamond shaped slate shingles adds elegance.

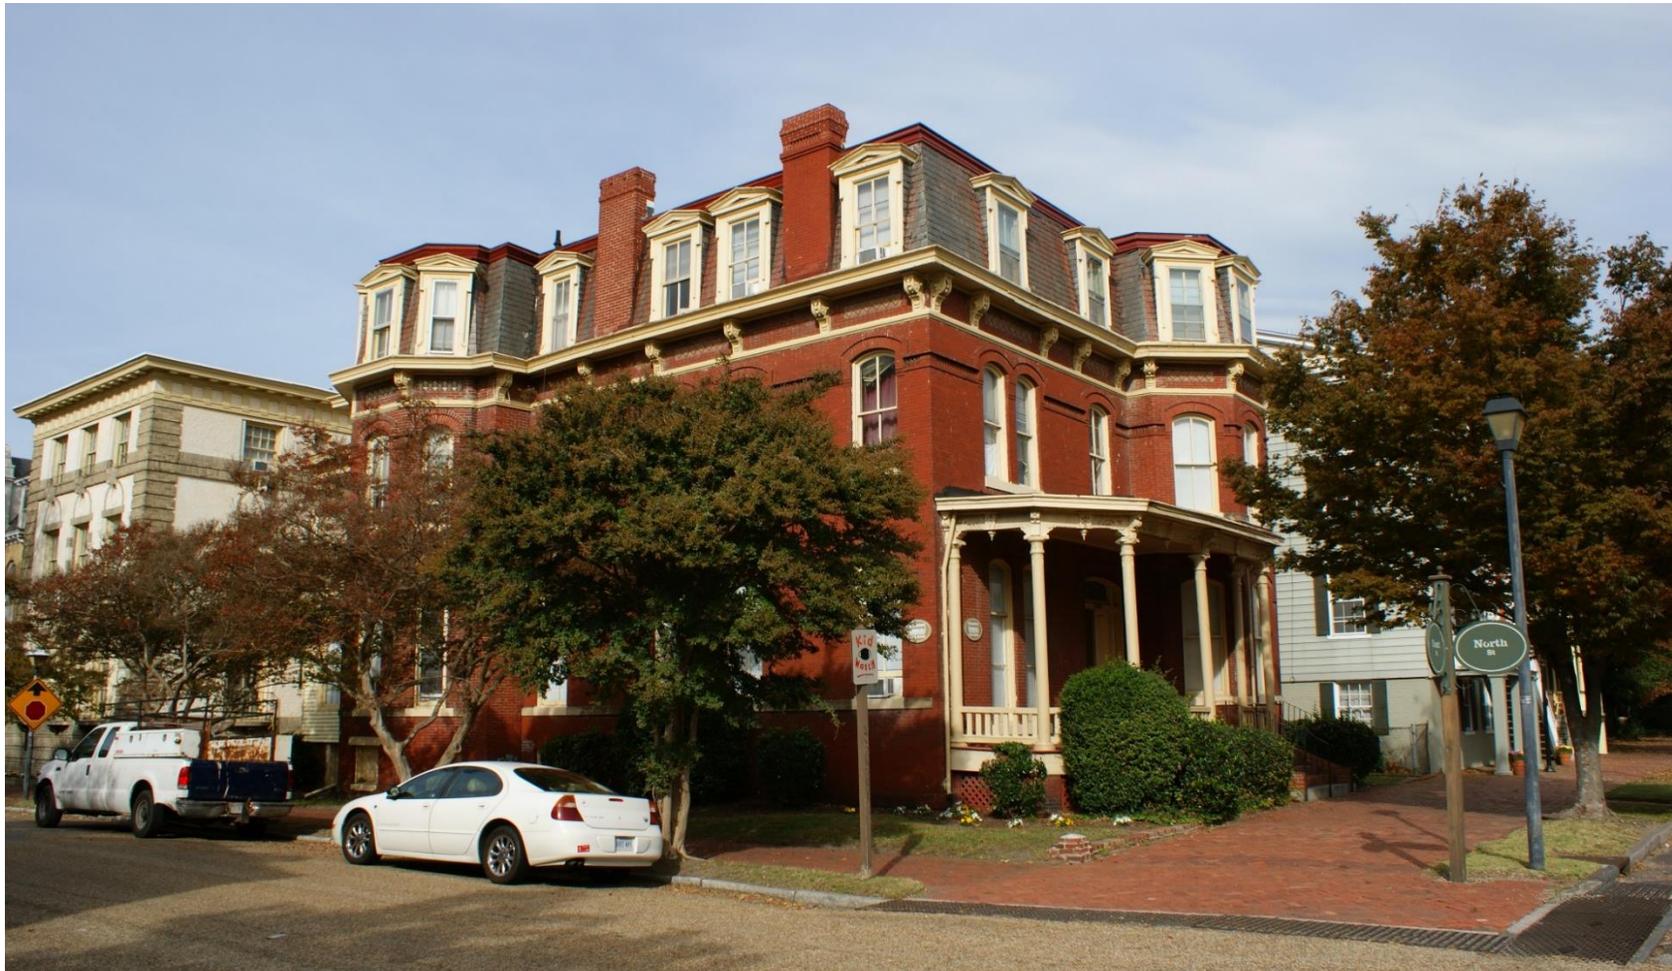
344 Court Street, Olde Towne

The Second Empire Style Building is capped off by a slate mansard. The steeply pitched, nearly vertical shingle exposure expresses the shingles more visibly from the street. Brown or red stains on the slate shingles are often caused by rust from wearing steel flashing or other on-roof metal products.

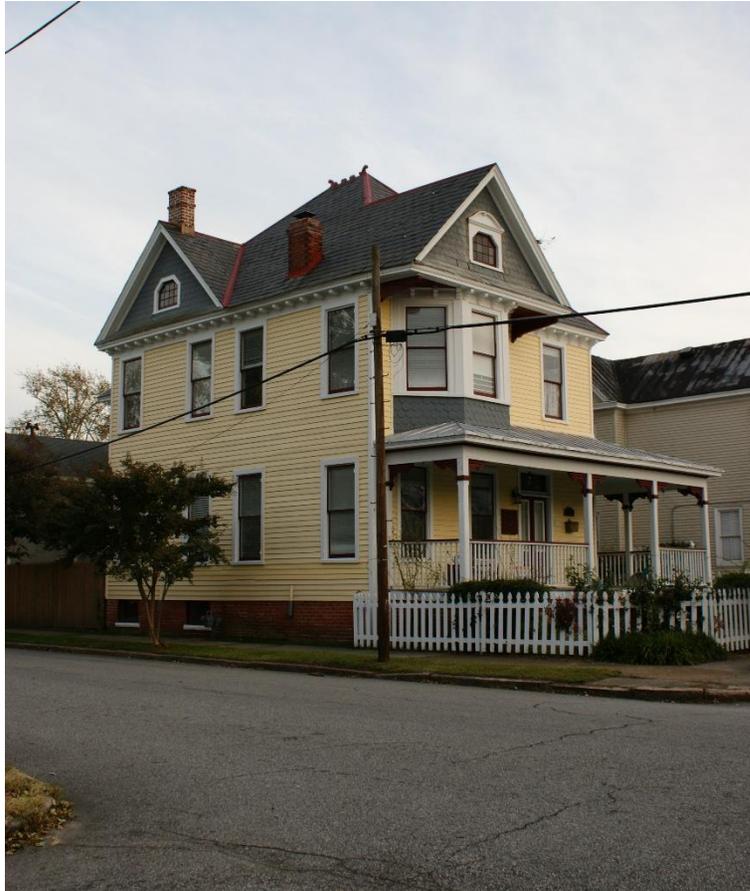
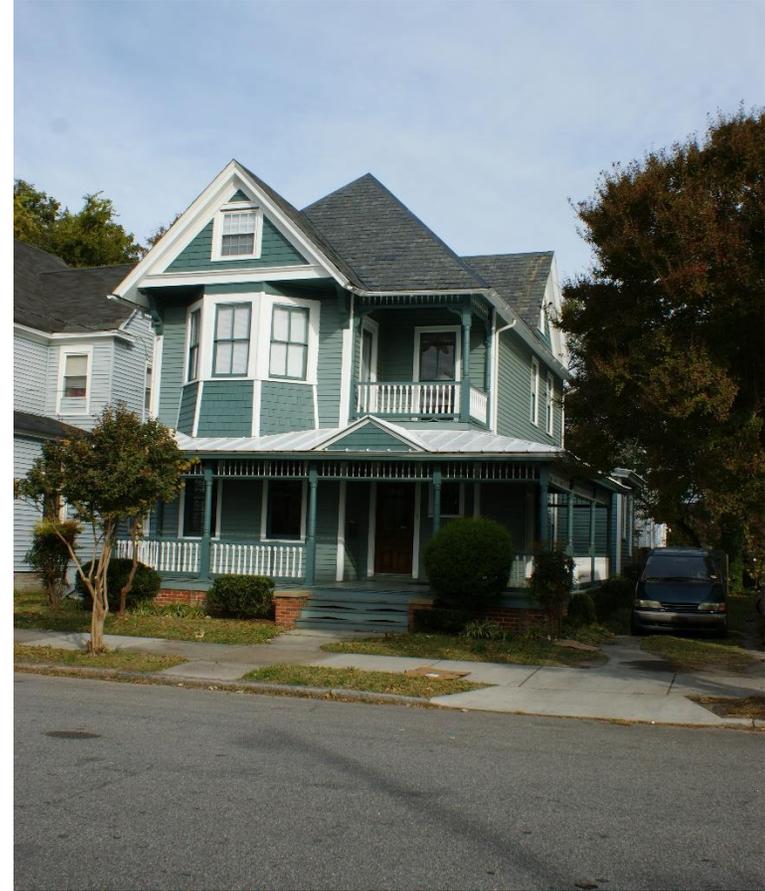
Slate shingles on both homes are in fair/good condition. Copper ridge flashings and valley flashings on 101 Linden are open and expressed to view.

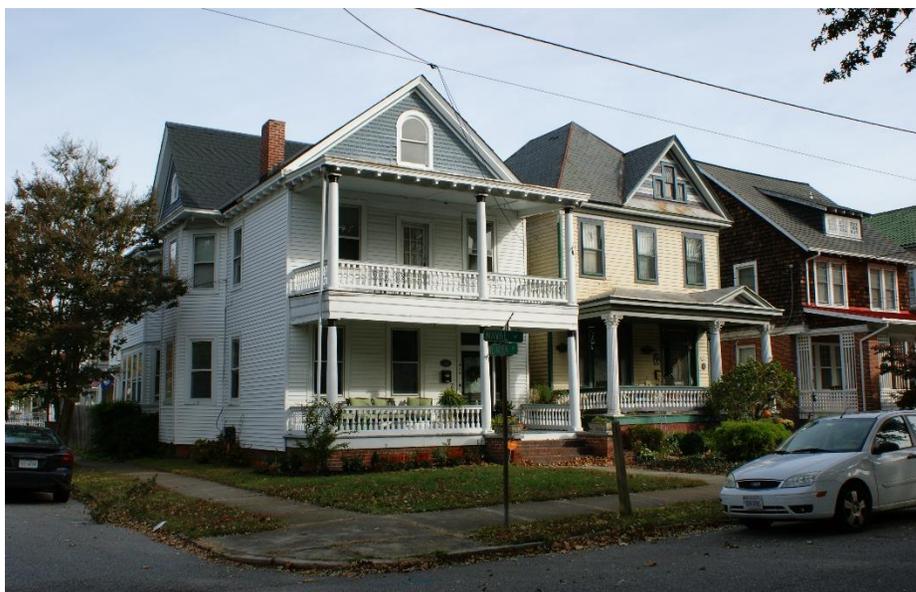
1044 and 1048 Naval Avenue, Park View

The slate roof shingles are in fair condition on these homes. Copper ridge flashings and open valleys show the roof was properly flashed at the time of the roof installations.

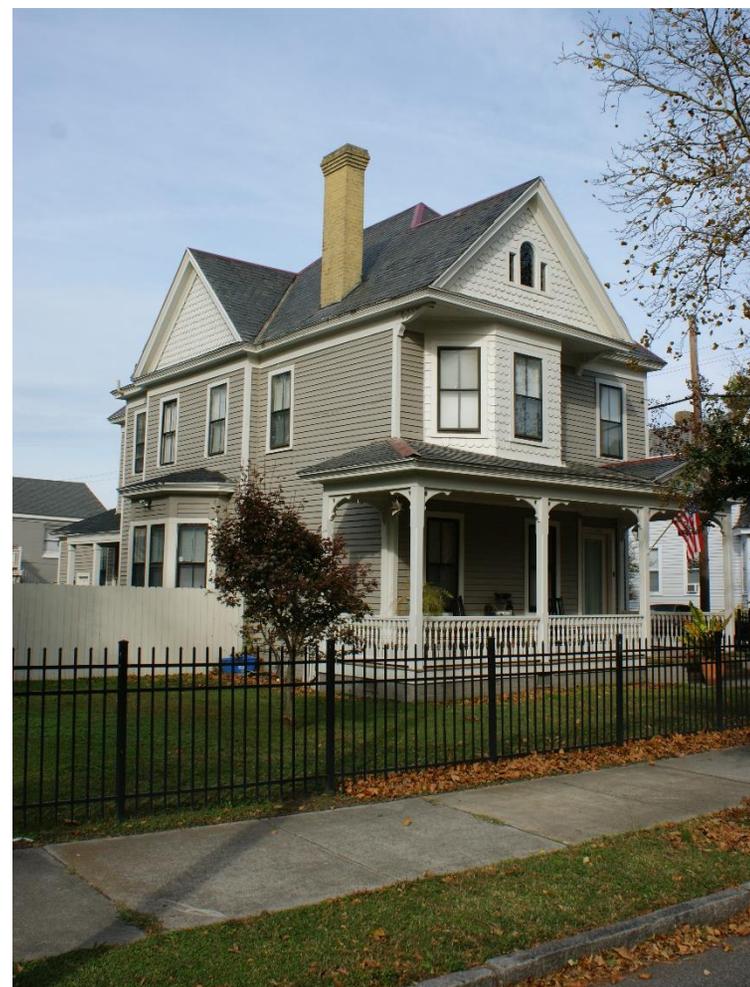
100 Riverview Avenue, Park View

This slate shingle roof is in fair condition though there are some areas that appear to need repairs and should be inspected by a qualified slate roofer.

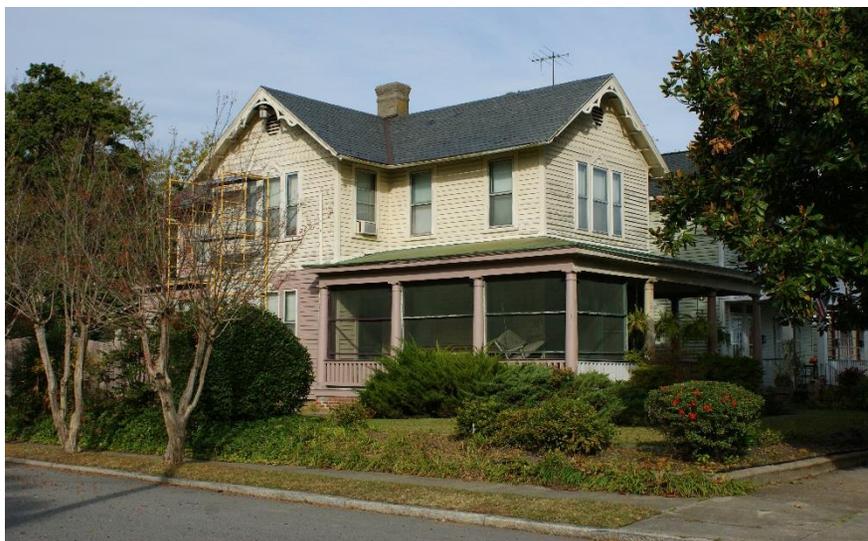
38 Riverview Avenue, Park View

Some portions of this slate roof is exhibiting signs of moderate damage and should be inspected.

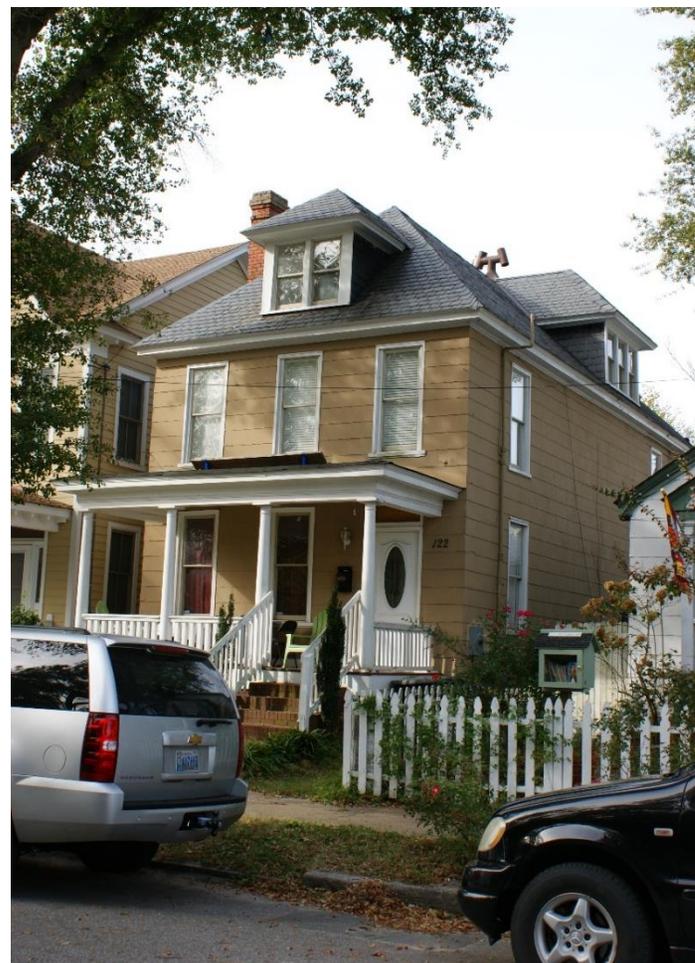
122 Riverview Avenue, Park View

This slate roof appears to be in good condition and is doing its job protecting the building from the elements while expressing the historic character of the neighborhood in a simple fashion.

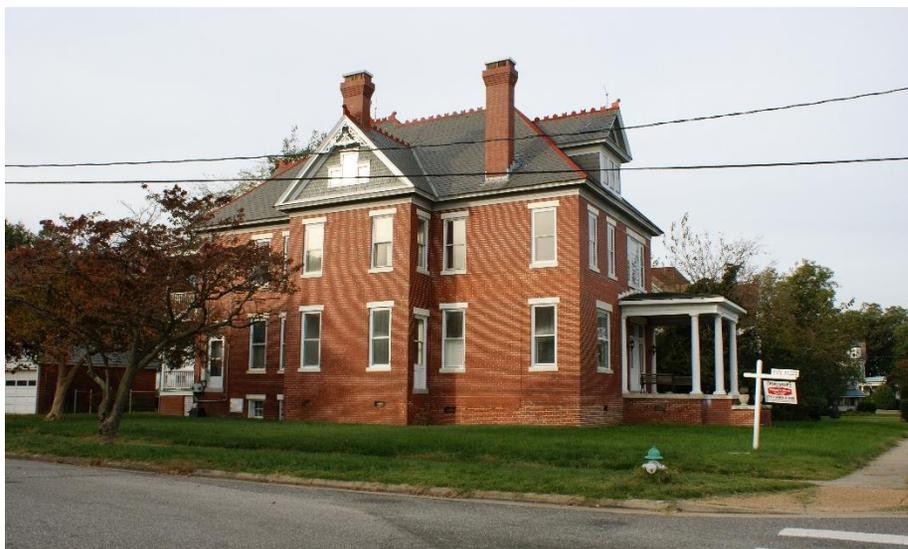
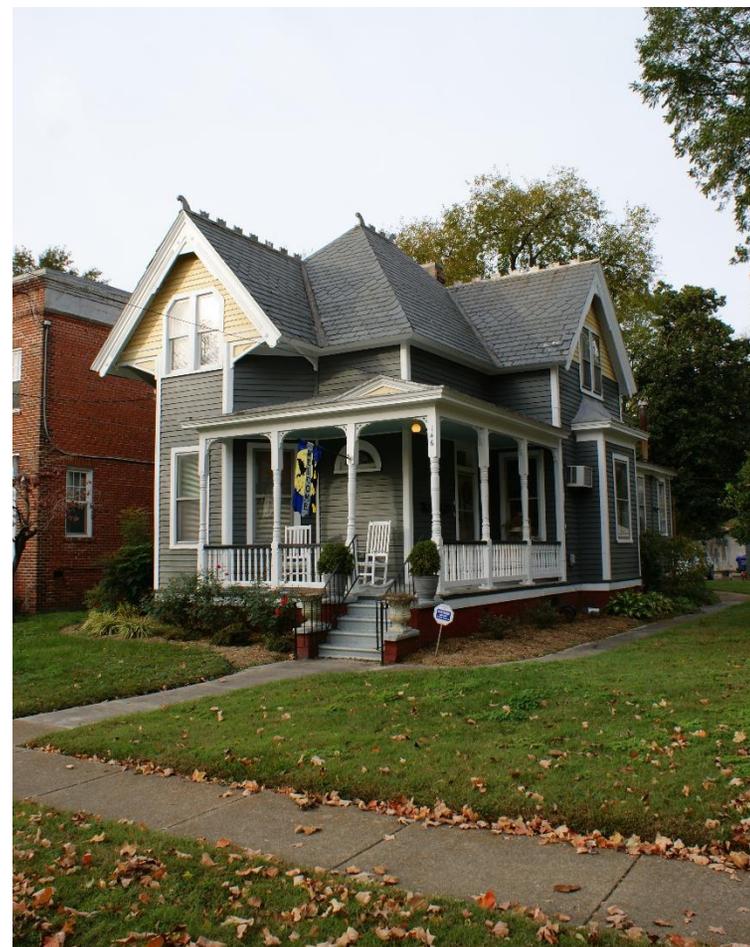
Roof shingles at these homes are in fair/good condition. Metal ridge cap expresses a unique detail and enhances the character of the neighborhood. 146 Florida Boulevard has a middle row of diamond slates for added charm.

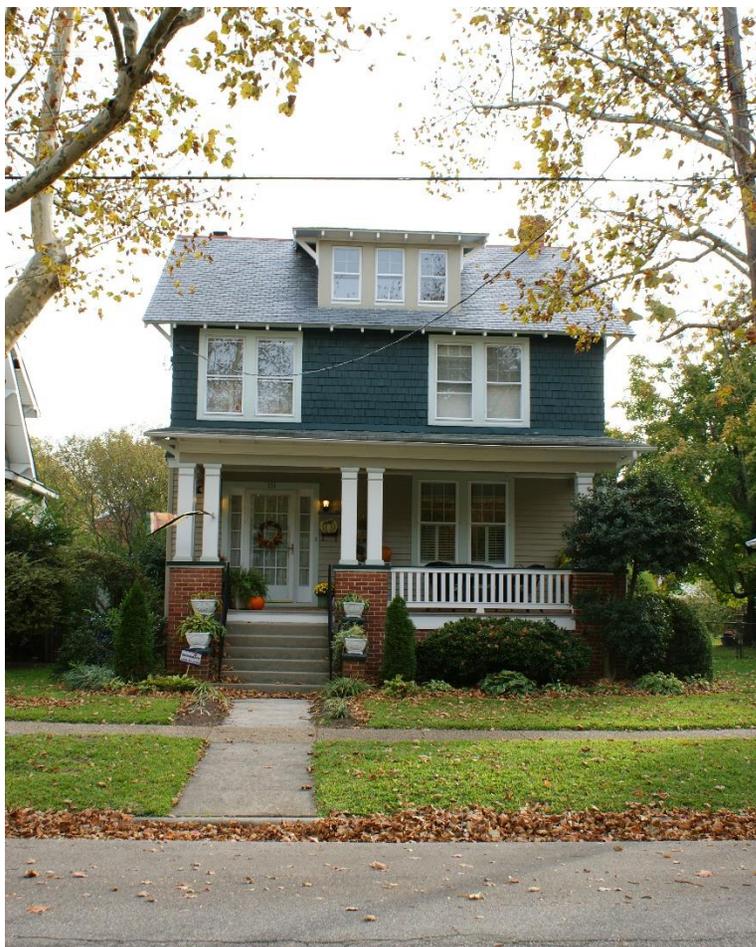
151 Florida Boulevard, Port Norfolk

This slate roof appears to be in good condition. The simple roof form decreases the labor costs incurred during repair or replacement.

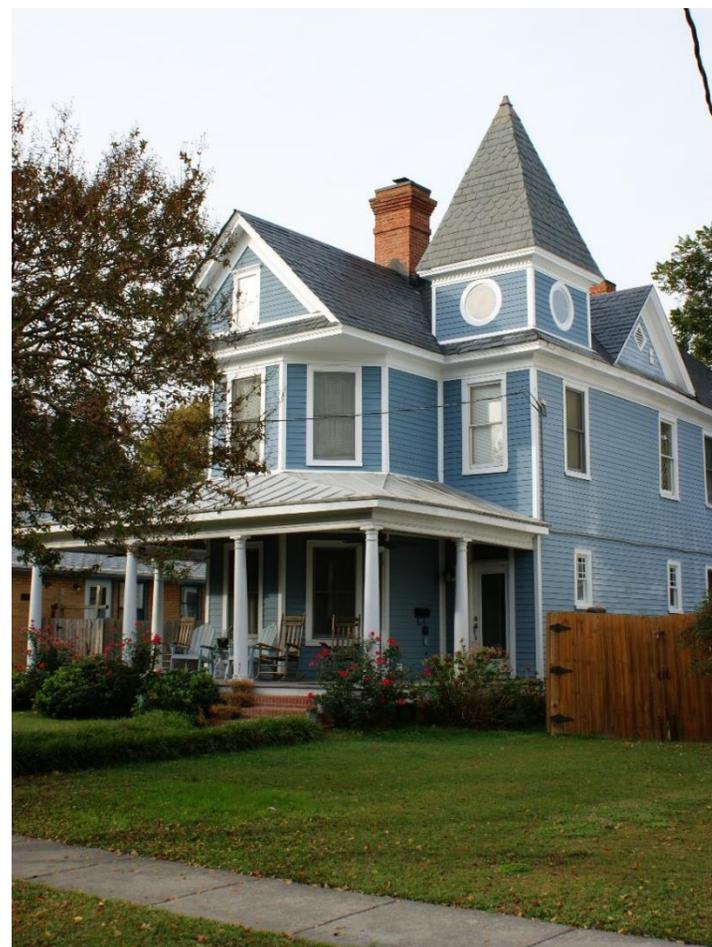
158 Broad Street, Port Norfolk

Roof shingles are in fair/good condition. The steeply pitched tower element with metal cap detail and diamond shingle patterns enhances the character of the home and neighborhood.

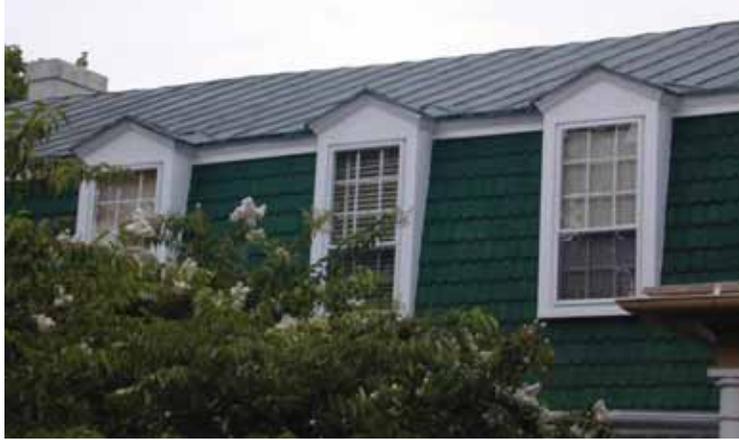
An early gambrel roof is clad in two materials, an eighteenth-century, period-appropriate wood shingle and the later standing-seam. Metal roofs replaced wood roofs starting in the mid-nineteenth century to lower fire dangers, especially in urban areas.

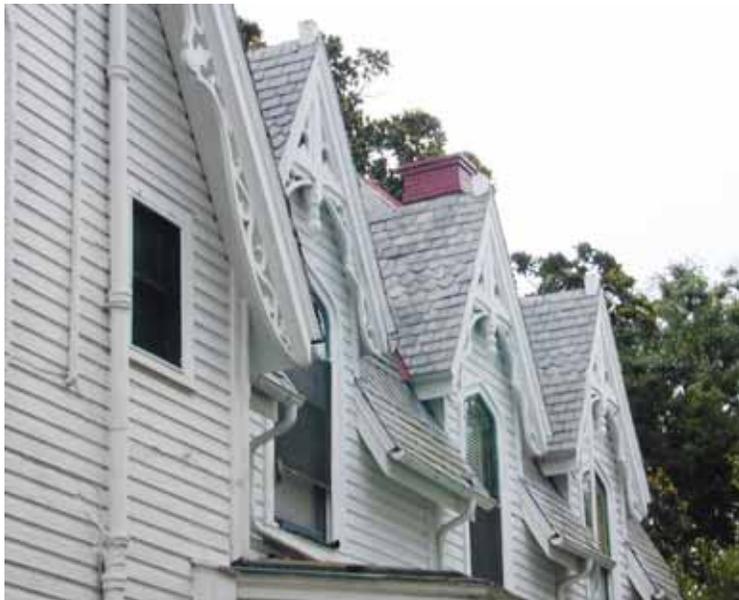
Rectangular slates are punctuated with rows of curved, or fishscale shingles, to provide a decorative appearance on these wall dormers.

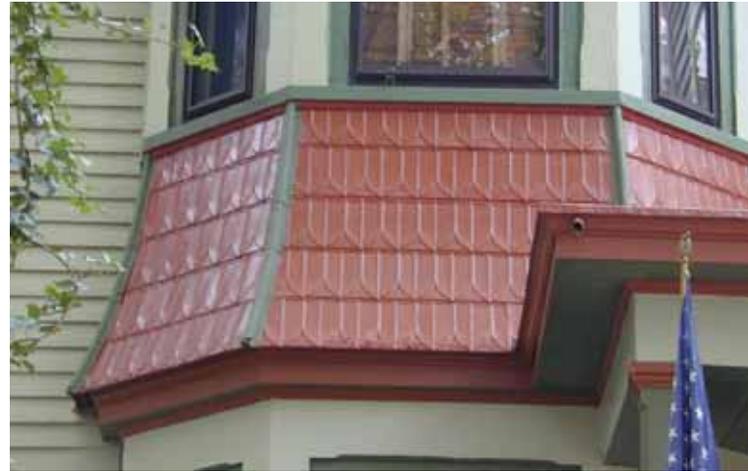
The area between two levels of a projecting bay is clad in painted metal shingles, a product that gained popularity in the late nineteenth century and may be appropriate for certain Victorian styles.

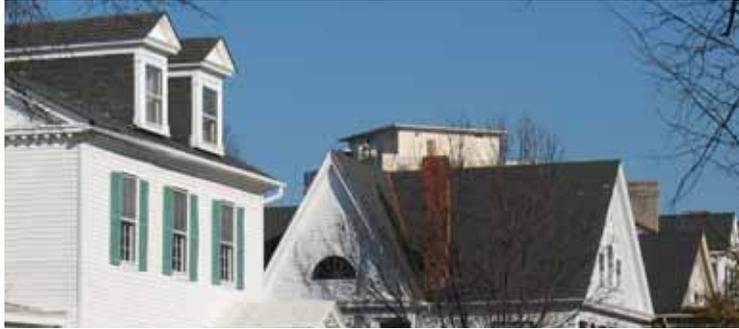
When a uniform dark gray color is achieved, it is hard to tell upon first glance whether the roof covering is slate, artificial slate, or asphalt shingle.

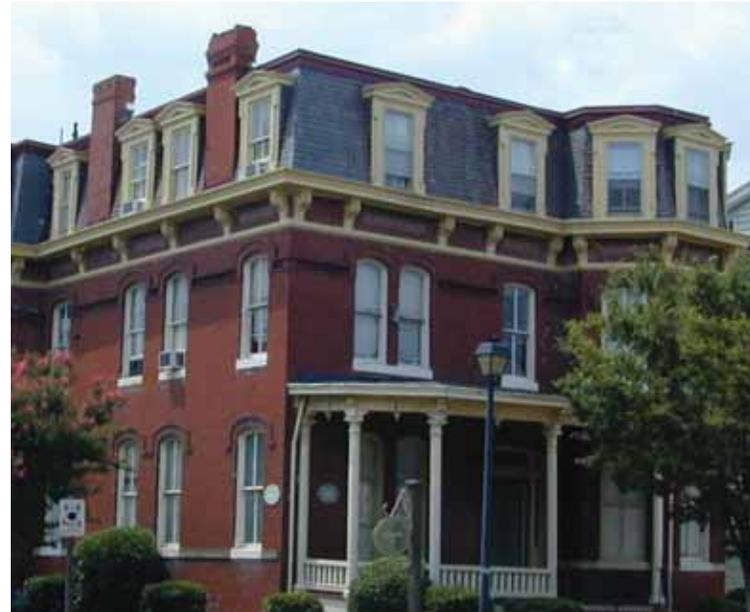
A rare example of a Mansard roof. This French roof style originated in an attempt to avoid paying taxes on the attic story of a residence.

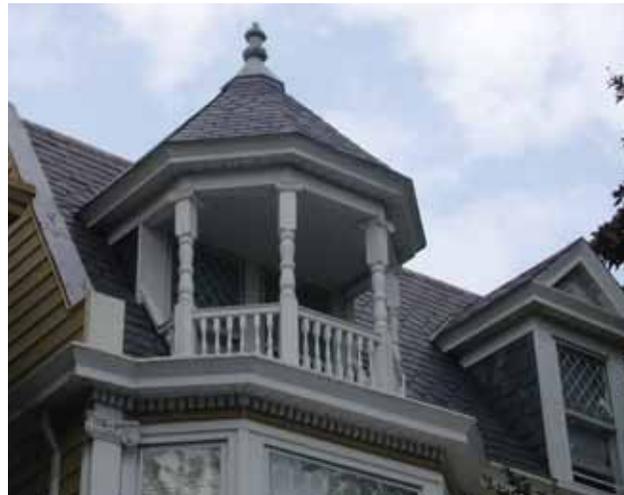
Clad in patterned slate shingles, this gable roof is punctuated by a gabled dormer and conical capped tower with cutaway porch bay.

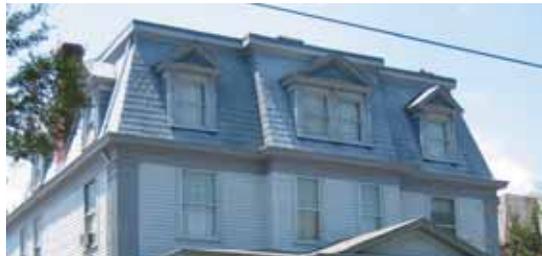
This is a rare example of a Mansard roof found in Park View. This French roof style originated in an attempt to avoid paying taxes on the attic story of a residence.

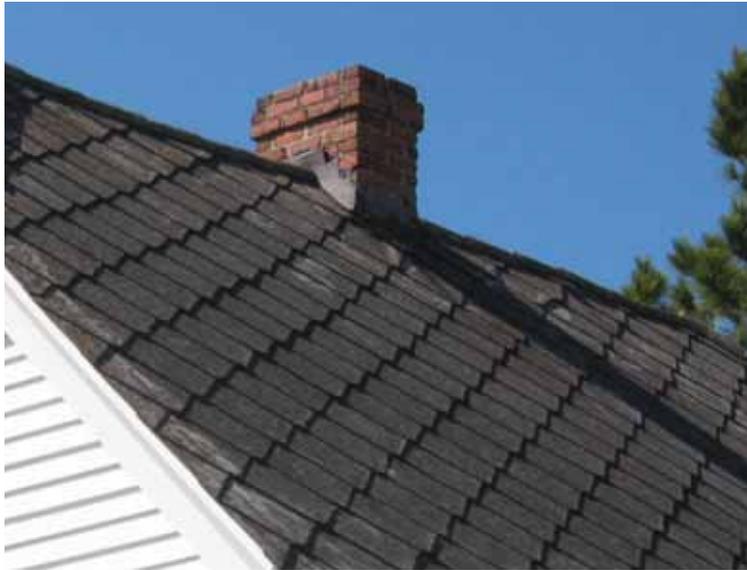
This diamond pattern is indicative of an asbestos-cement shingle roof.

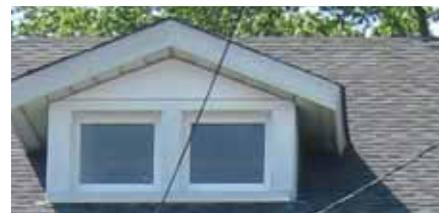
Dark gray asphalt shingles may be an appropriate substitute for an asbestos-cement shingle roof that has reached the end of its life expectancy.

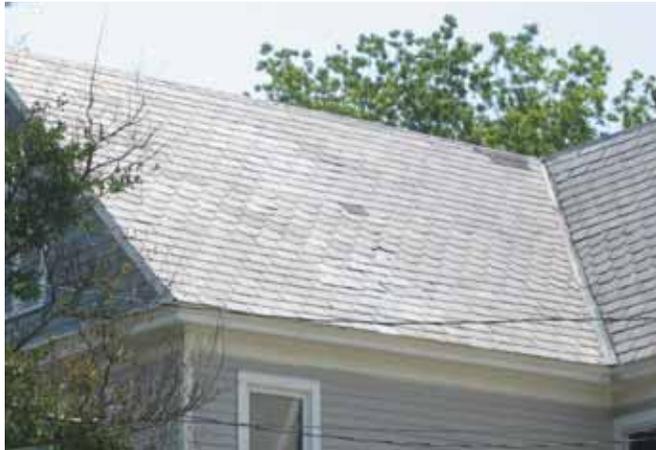
Rectangular slates are punctuated with rows of curved, or fishscale shingles, to provide a decorative appearance.

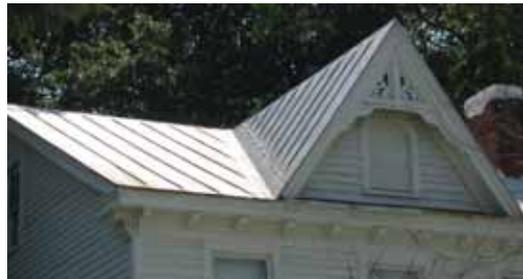
Standing-seam metal is an appropriate historic roofing material for many of Park View's historic structures.

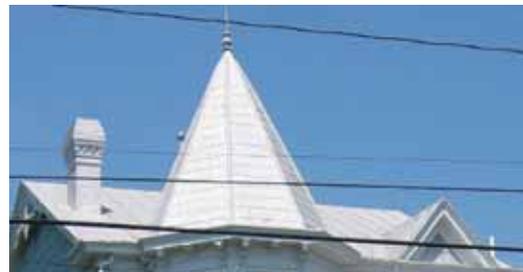
Metal shingles were often used for the conical roofs of Queen Anne towers and continue to be available.

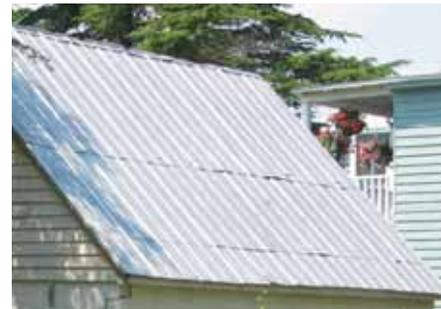
5V crimp is an economical metal roof material that may be used on accessory buildings such as sheds and garages.

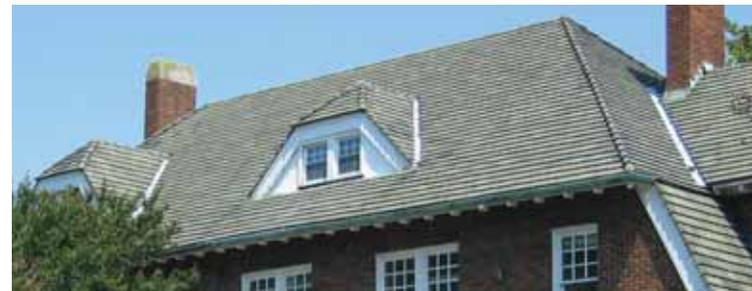
The flat clay tile shown here is a rare example used as an alternative to slate.

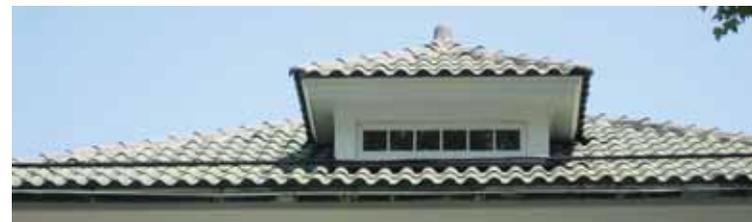
Barrel-shaped clay tiles reflect a Mediterranean influence in several early twentieth century styles.

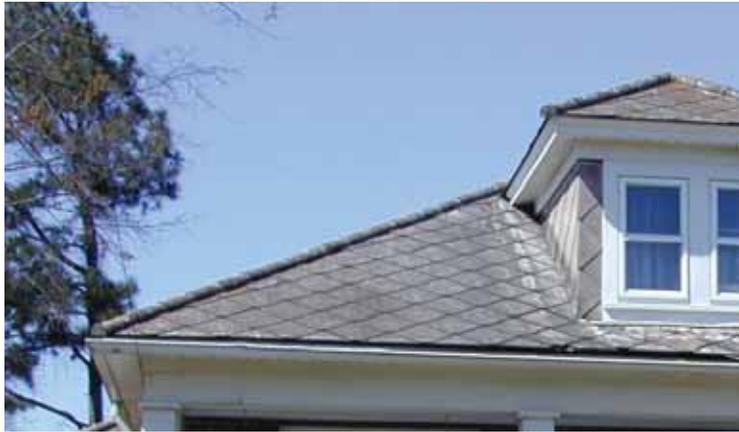
Asbestos-cement shingles were an economical and long-lasting roof material in the early twentieth century.

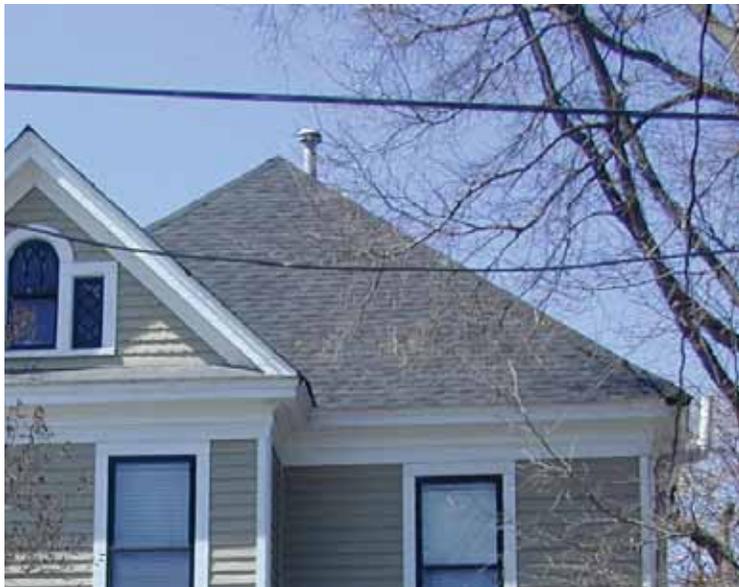
The uniform dark gray appearance of this asphalt-shingle covered roof helps this substitute roof material fit in with the Port Norfolk Historic District.
