HISTORIC DISTRICT HOMES - ROOF ANALYSIS

February 3, 2015

REPORT OBJECTIVES

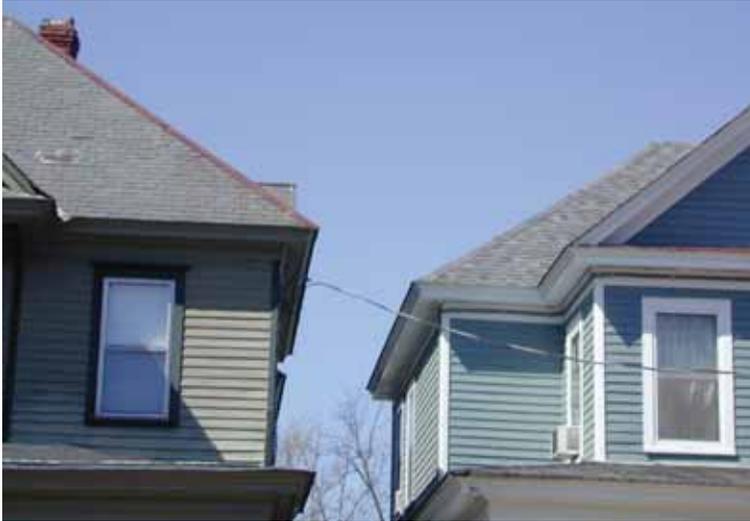
The house to the left retains its original slate shingles and the house to the right has an asphalt shingle replacement roof. The new shingles approximate the visual appearance of the historic material in color and pattern.

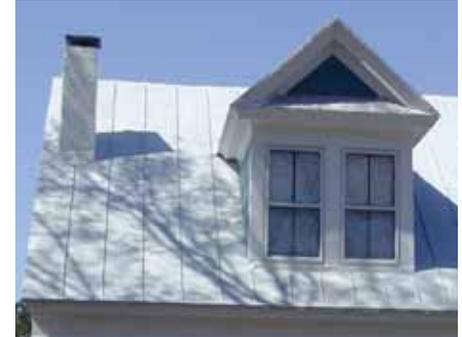
Standing-seam metal is available in a variety of materials including galvanized, terne, pre-painted terne and terne-coated stainless-steel.

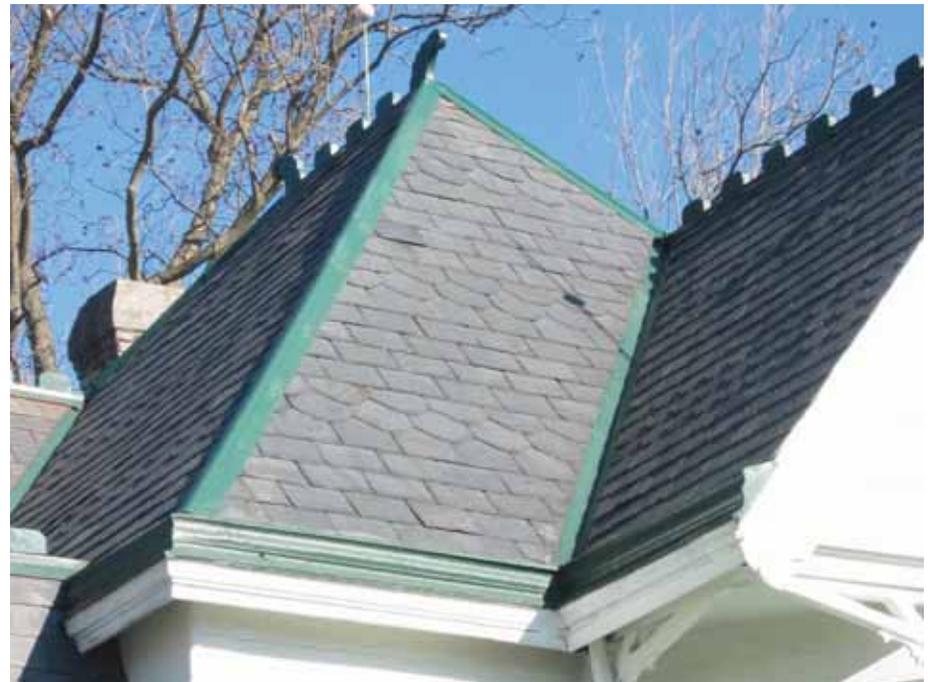
Metal roof cresting should be retained and maintained.

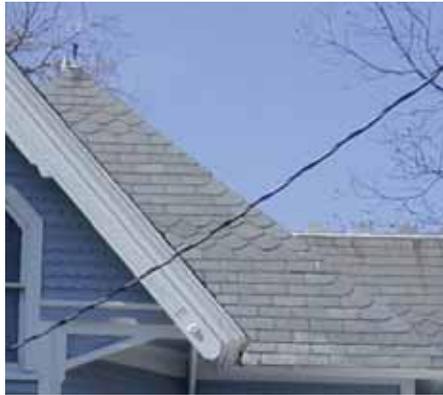
Patterned slate roofs are a character-defining feature in the Port Norfolk Historic District.

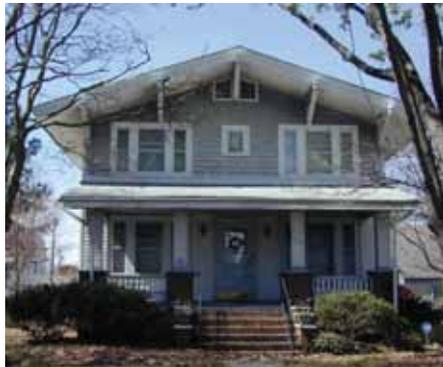
Overhanging eaves accented by brackets are a hallmark of the Craftsman style.
